**From:** John Brunini <Johnny.Brunini@butlersnow.com>  
**Sent:** Monday, August 04, 2014 1:32 PM  
**To:** Kato, Linda  
**Cc:** Heimdal, Monica; 'Kyle Brock'; Greg Meyer  
**Subject:** Williston Village Mobile Home Park - Wetland Restoration Update  
**Attachments:** Letter to Linda Kato enclosing photographs.PDF

RE: Williston Village Mobile Home Park Wetland Restoration  
Docket No. CWA-08-2013-0032

Please consider this letter as an update of activities concerning the restoration of the wetland within the Williston Village Mobile Home Park, Docket No. CWA-08-2013-0032.

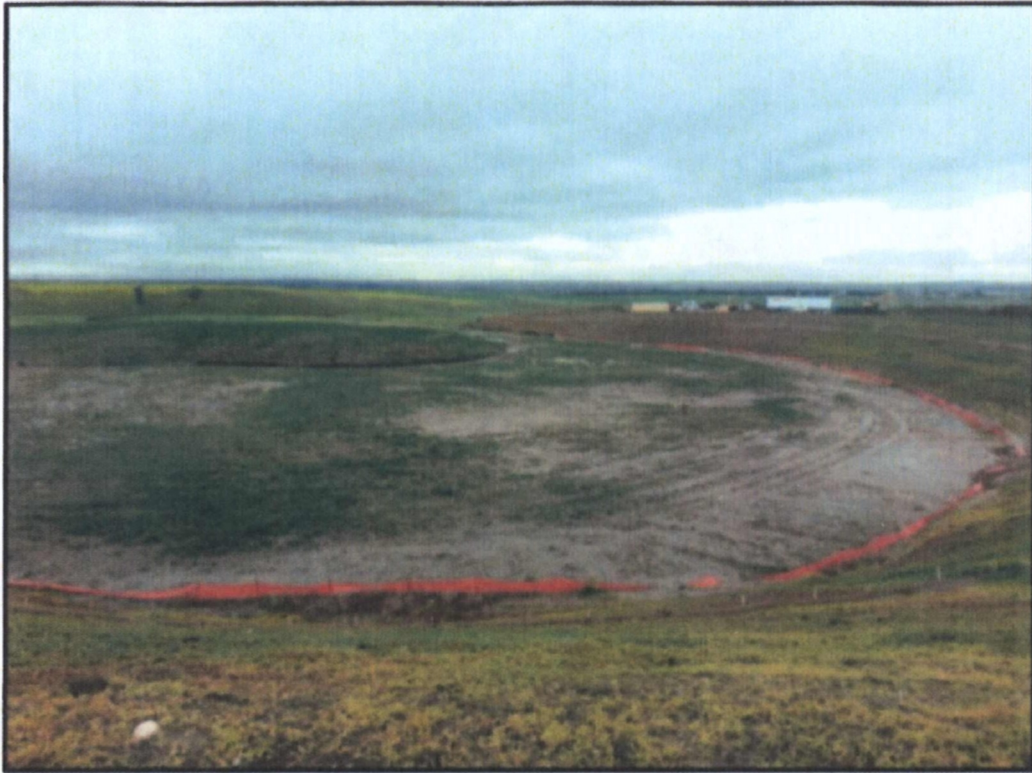
Photograph 1 View of restored wetland area facing north from the adjacent side-slope. The wetland area is being naturally re-vegetated by seeds from the adjacent wetland areas. The erosion control structures are evident in the photograph and these include the orange sediment fence and straw wattles along the side-slopes. These were installed during the fall of 2013. Russian thistle and other weed species have become established on the side-slopes of the restored wetlands. The weedy vegetation is being managed (mowed) and will help with erosion control until the sides-slopes are seeded with the native species seed mixture next spring (2015).

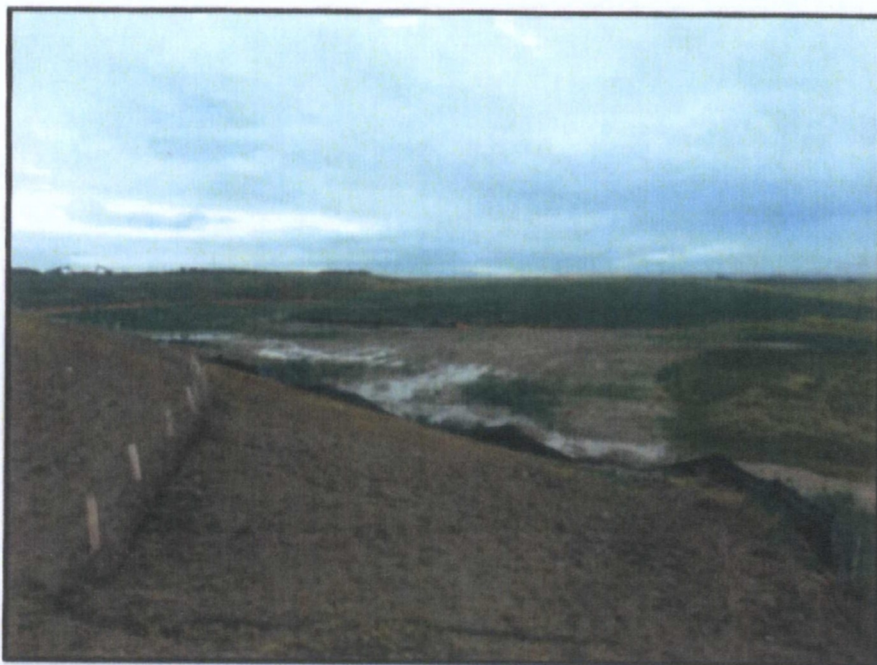
Photograph 2. View of western end of restored wetland area. A distinct line of vegetation indicates the impacted area.

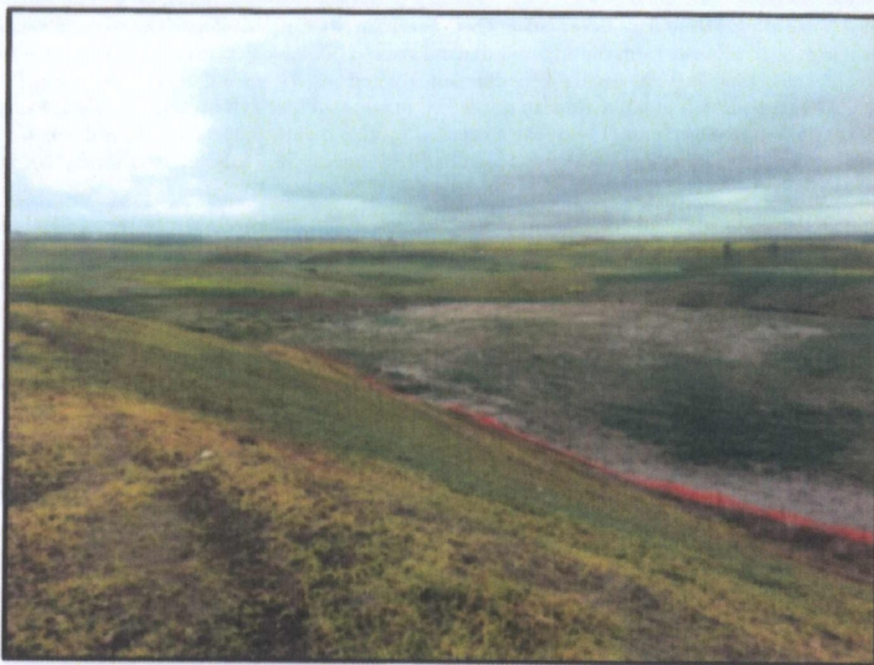
Photograph 3. View of western end of the restored wetland area.

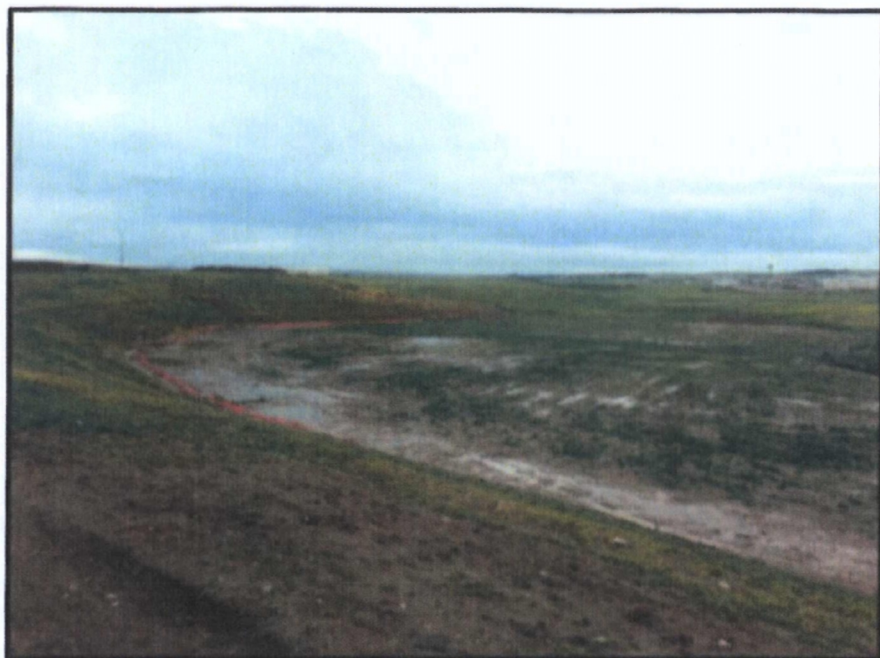
Photograph 4. View of restored wetland area and side-slopes facing west. Small areas of inundation were present in the wetland at the time the photograph was taken.

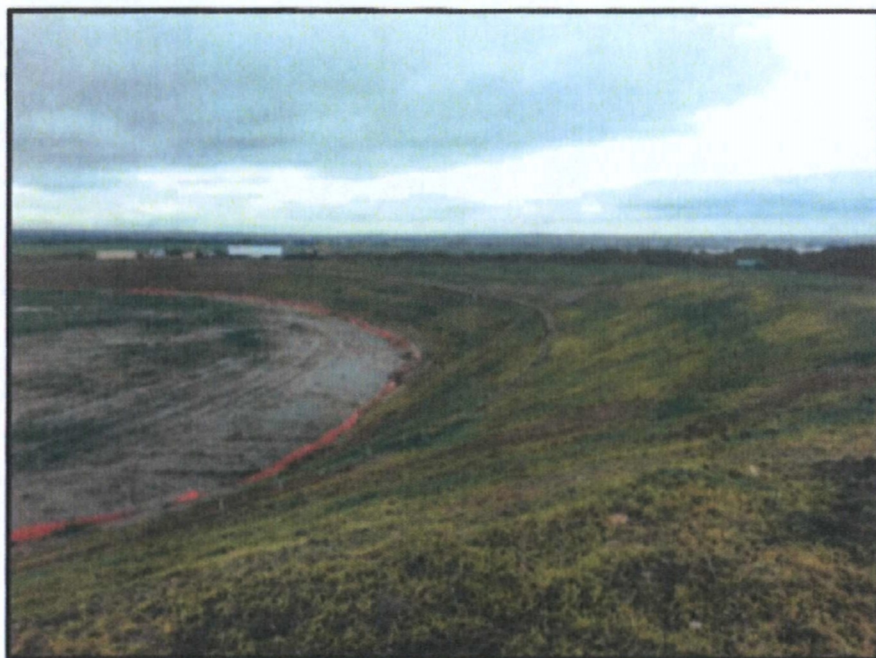
Photograph 5. View of side-slopes facing east.

The side-slopes in the restored area have also not been seeded due to the extreme winter and spring and dry summer. Conditions remained unfavorable during the entire period of specified planting dates for the appropriate seed mixes, so we have decided to wait until next spring (per the dates listed in the restoration plan) in order to aid the success of the seeding effort. The side slopes at the site will be hydro-seeded next spring (2015) during the appropriate dates. Weedy vegetation, primarily Russian thistle (*Salsola kali*), has flourished along the side-slopes and is currently providing ground cover that aids in erosion control (see attached photographs). The ground cover, straw wattles, and sediment fence have stabilized the side-slopes. Russian thistle is not a noxious weed and can be effectively managed. These weedy species are being currently managed (mowed) and we will make efforts to eliminate them prior to the seeding activities in the spring.
